Manhole Inspection Summary

Manhole # S35KK1009MH

Insp Date: **3/10/07 10:45 AM**

Location Address: **208 STRATFORD RD**

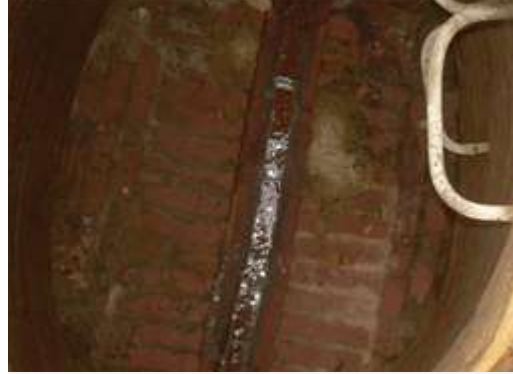
Top View

Evidence of surcharge - Bench debris.

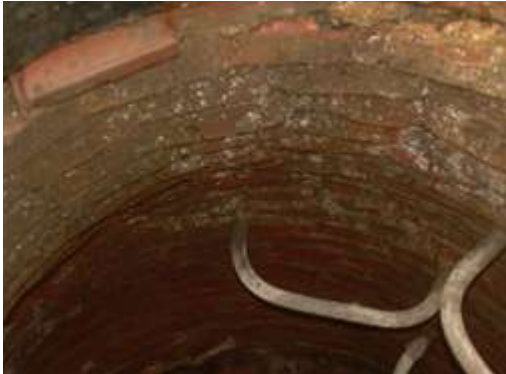
Defect

Frame leaks. Adjustment deterioration, loose brick and infiltration. Corbel and Barrel infiltration.

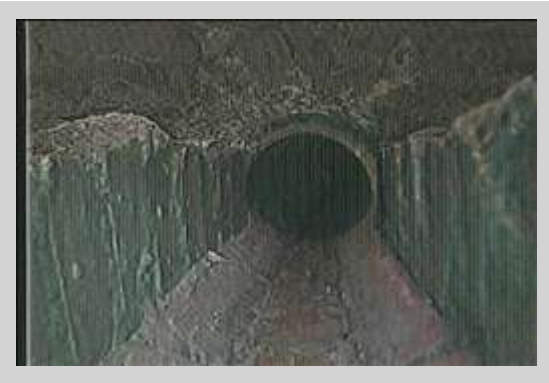
6 in. Circular Gravity Sewer Pipe Out @ 12 O'Clock

Barrel deterioration and infiltration. Channel deterioration.

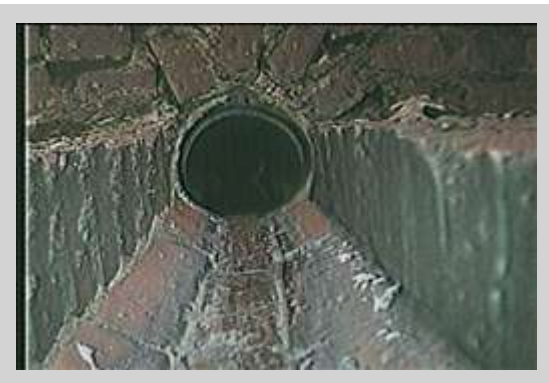
6 in. Circular Gravity Sewer Pipe In @ 6 O'Clock

Barrel deterioration and infiltration. Channel deterioration.

Infiltration: **None** Pipe Seal Cond: **Cracked**
